# Test Report

REPORT NUMBER:  
208405

**Item:** Model: CM Solar – SUNSLATE  
Material: Monocrystalline  
Appearance: Dark and blank  
Dimensions: 1210 x 600 x 5 mm (L x W x T)

**Method:** **EAD 090062-01-0404** Kits for external wall cladding mechanically fixed  
- Test 2.2.9 – Annex E Wind load resistance  
**IEC-61215-2:2021** Crystalline silicon terrestrial photovoltaic (PV) modules  
- Design qualification and type approval.  
- MQT 16: Static mechanical load test  
- MQT 17: Hail test

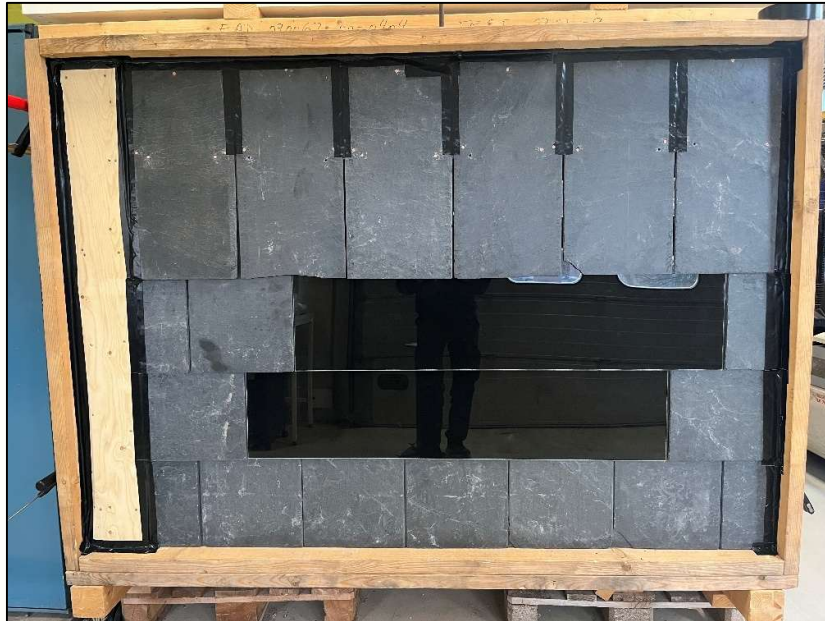
A maximum deformation of 19.1 mm was observed, but no mechanical failures were detected during the testing.

Figure 1 – Front of the test specimen mounted in the wind pressure test rig.

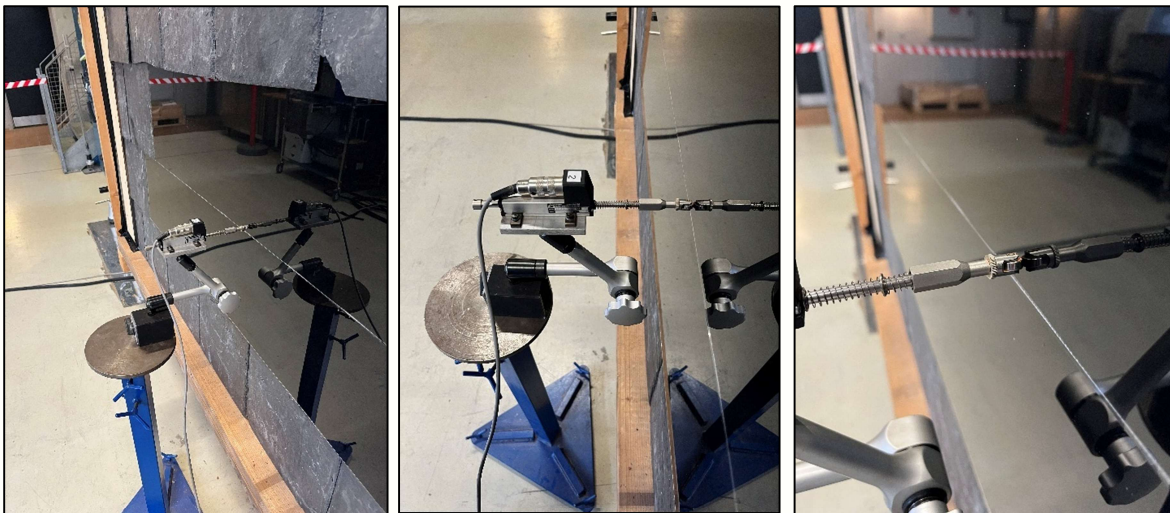
Figure 2 - The displacement sensor was mounted at the center of the test specimen.

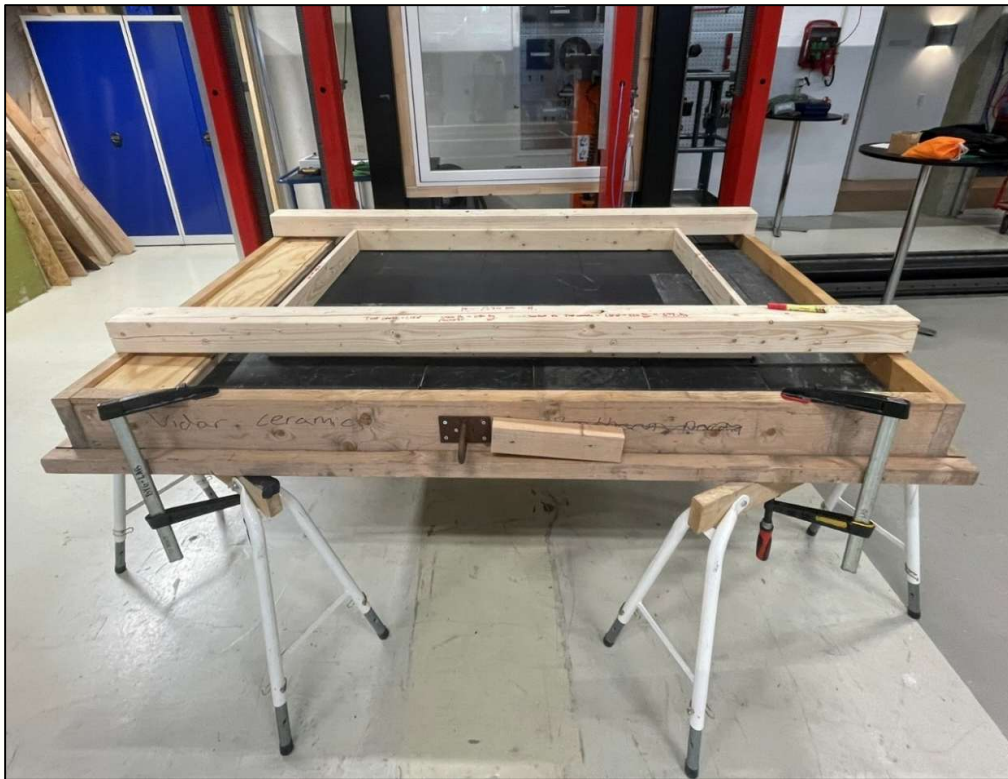
No visible signs of failure or breakage were observed on the test object.

Figure 5 – Test setup for snow load.

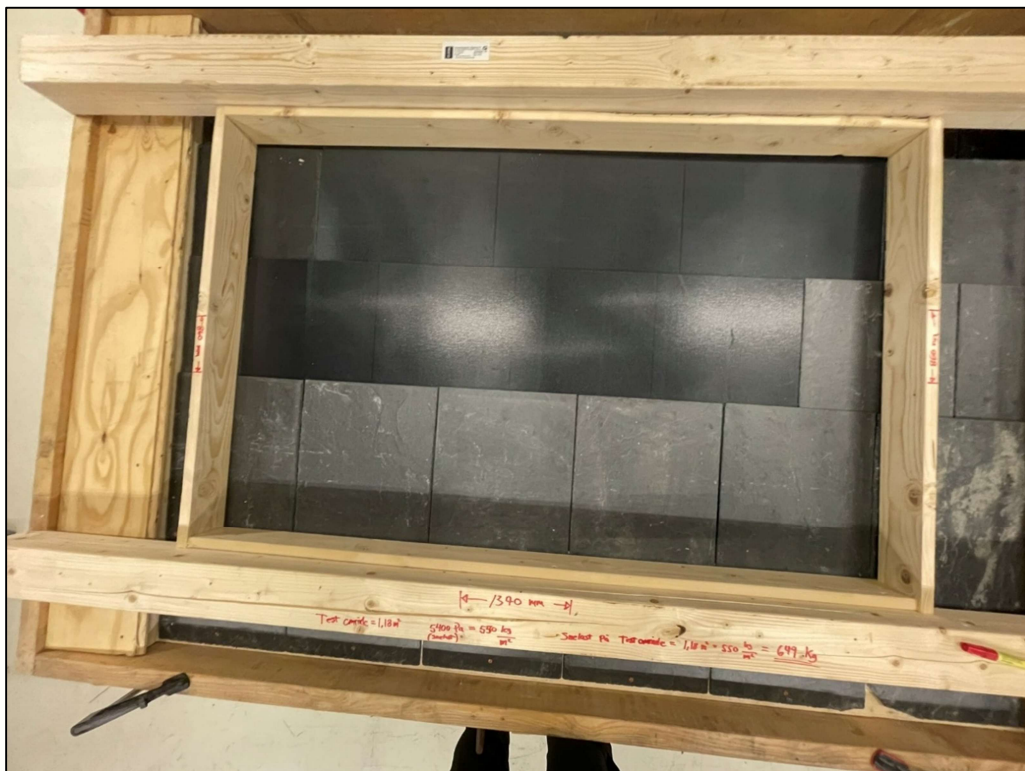
Figure 6 – Ekstra test frame to control the loading area.

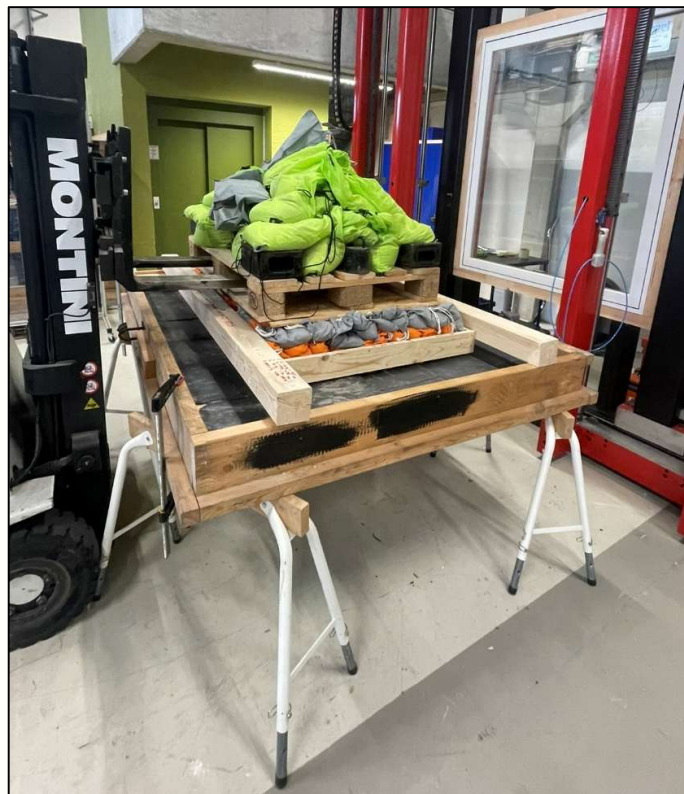
Figure 7 – Snow load applied with sandbags.

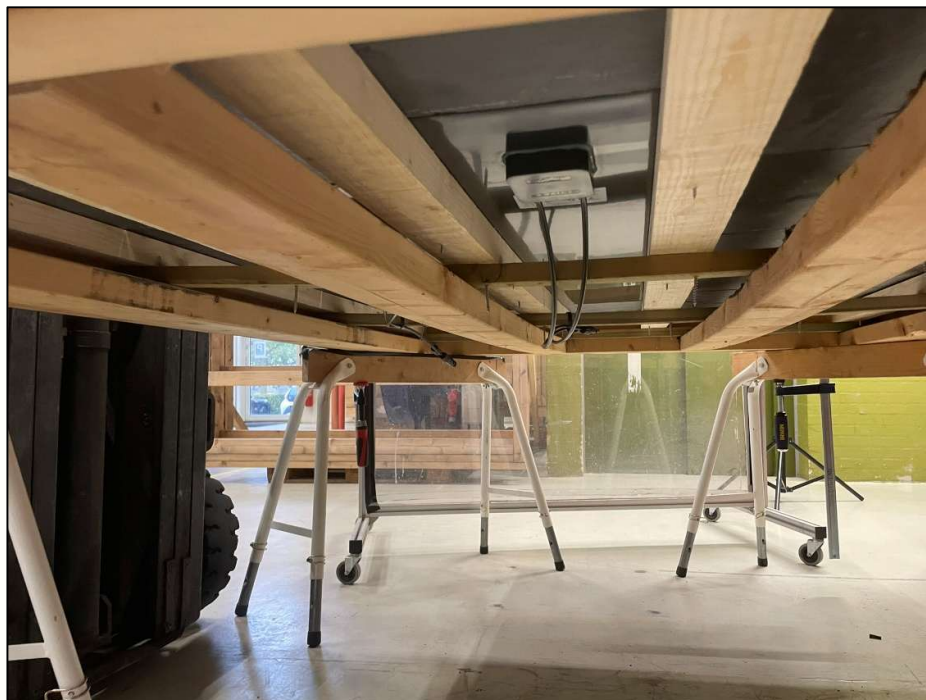
Figure 8 – Deformation of the test specimen during the snow load.

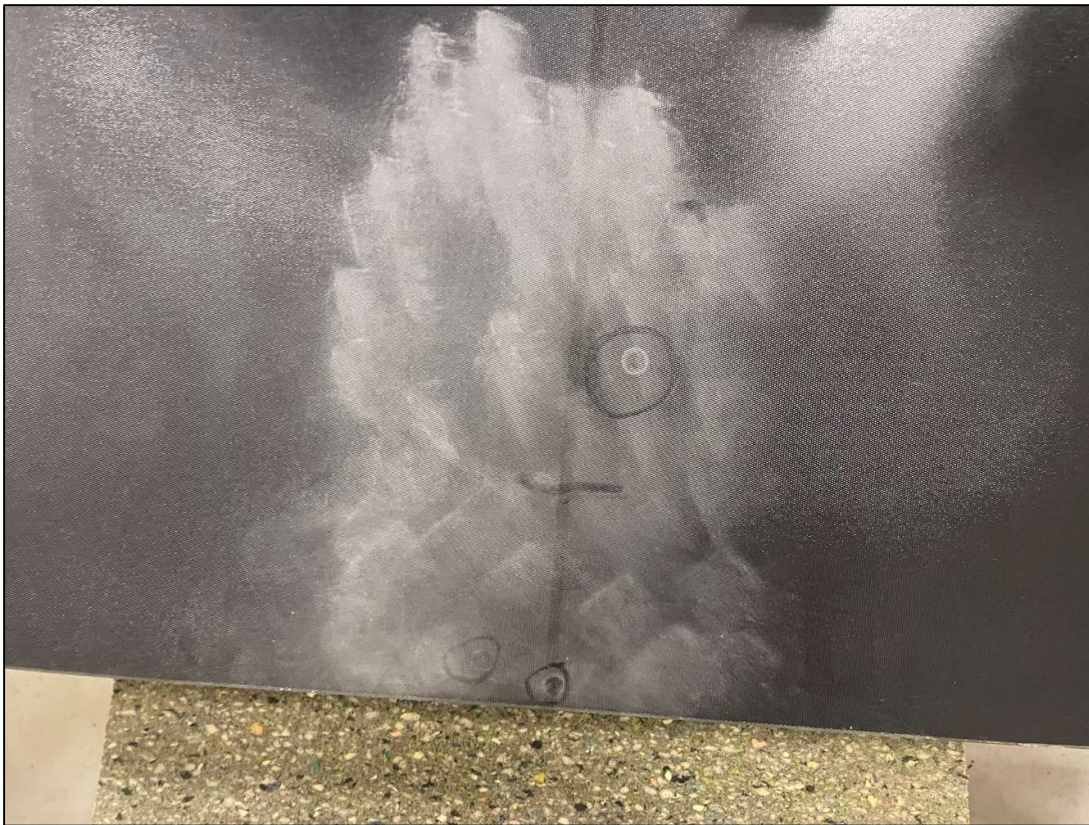
No visible damage was observed after the impact test.

Figure 11 – Impact locations.
